# FLOATING DRY DOCK ACCIDENTS INVOLVING TRANSVERSE BENDING FAILURE OF THE PONTOON

R.E. Heger, Heger Dry Dock, Inc., USA

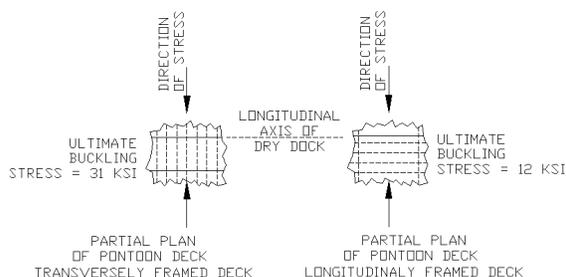
FIGURE 1  
COMPARISON OF PANELS

in deck panels that could buckle if the design limits were exceeded however. Figure 1 shows the relative difference in stiffener orientation between longitudinally framed and transversely framed deck panels when resisting compression induced by transverse bending of the pontoon.

According to Reference 1, a panel framed longitudinally does not have as great a capacity to resist transverse buckling as a transversely framed panel of similar dimensions. A 600 mm x 2100 mm (2' x 7') panel with plate thickness of 12mm (1/2") has an ultimate buckling stress (stress in plate at time of failure) of 214,000 kPa (31,000 psi) if orientated transversely and 82,700 kPa (12,000 psi) if orientated longitudinally. This means the factor of safety before failure is less for a longitudinally framed pontoon than for a transversely framed pontoon.

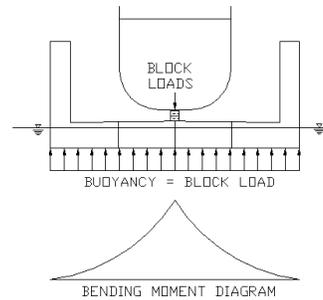
FIGURE 2  
BENDING MOMENT DIAGRAM  
BUOYANCY EQUALS LOAD

When a loaded tank is deballasted, the buoyancy created by removing water is offset by the weight of the vessel being lifted. The buoyancy is spread across the width of the pontoon but the vessel load is concentrated at the center (on the keel blocks). This creates a tendency of the pontoon to bend up around the keel block. See Figure 2. This puts the bottom plate in tension and the pontoon deck plate in compression. Typically, the pontoon is designed to resist the full buoyancy of the tank offset by an equal but opposite vessel load on the keel blocks. If the block load over a tank exceeds the buoyant capacity of that tank the excess load must be compensated by buoyancy from other areas of the dock. In this case, that additional buoyancy came from the unloaded tanks at each end of the dock. See Figure 3.

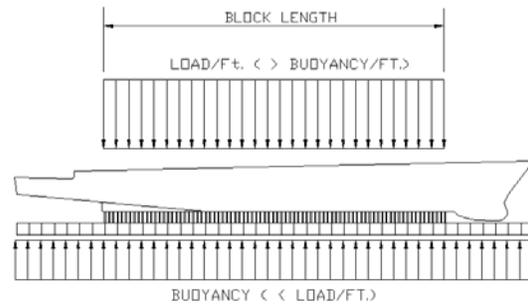
FIGURE 3  
DISTRIBUTION OF BUOYANCY

When an unloaded tank is deballasted there is no ship weight to offset the increased buoyancy. The pontoon in this area wants to rise out of the water but is held down by the vertical walls of the wings.

The excessive buoyancy is transferred longitudinally down the wing walls as shear load to the area where the ship loads exceeds the local buoyancy. This shear load in the wing walls provides the additional force required to hold up the ship. This additional uplift force is located at the wing wall vertical shells and can greatly increase the transverse bending moment on the pontoon. This increase in moment causes an increase in the bending stresses in the top and bottom plates of the pontoon. See Figure 4.

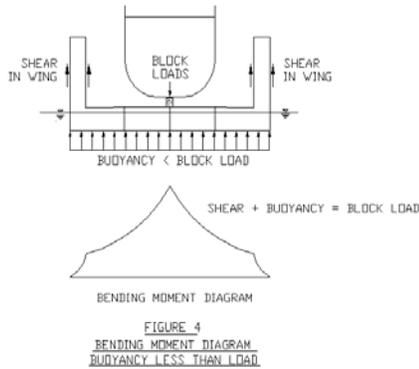
This accident was caused by this phenomenon. As the vessel was being pumped up, the water in the loaded tanks was approaching minimum levels. The crew began to pump more out of the unloaded end tanks to attempt to get the pontoon deck out of the water. The additional buoyant force from the end tanks was transferred down the wings to the overloaded tanks.

This increased the transverse bending force on the pontoon to the point when the pontoon deck plate panels buckled (probably first in the area of the ship's knuckle). Once one area failed the remaining panels would have failed "domino" style. The dry dock was a total loss.

The accident could have been prevented if the vessel's load per meter on the blocks was calculated and compared to the dock's rated capacity. It would have been seen that the block load imposed by the vessel was 150 metric tons per meter (45.0 long tons per foot) versus a rated capacity of 100 metric tons per meter (30 long tons per foot). The vessel could have been lightened by unloading prior to docking or the shipyard could have refused to dock the ship.

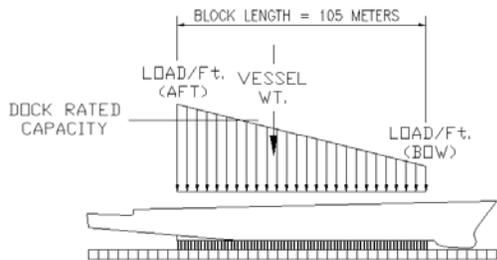
FIGURE 5  
BLOCK LOADING WITH ORIGINAL KEEL BLOCK LENGTH

Case 2 involved a 14,200 metric ton (14,000 long ton) capacity floating dry dock which was docking a CG-47 Class Naval Vessel. The vessel weighed approximately 9,350 metric tons (9,200 long tons) at the time of docking. Before dry docking, block loading calculations were performed which showed the vessel's load per meter would exceed the dock's rated capacity if the standard keel block arrangement was used. See Figure 5. (These vessels have a very long fantail overhang aft of the last block that results in a high load per meter for a short distance on the aft blocks.)

To reduce the load per meter, the shipyard added additional keel blocks along the fantail. This had the benefit of lengthening the effective keel line and reducing the eccentricity between vessel LCG and block centerline. The result of the longer block line was a reduction in the load per meter to an acceptable value. See Figure 6. A pumping plan was prepared based on this loading.

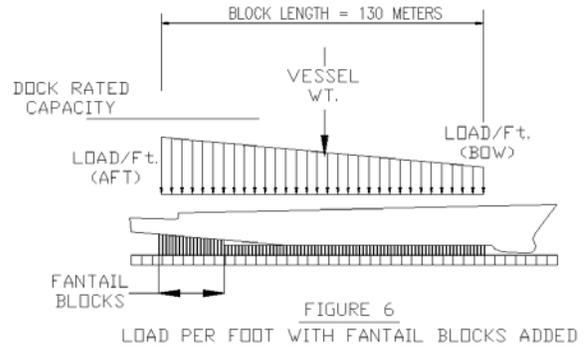
The keel block loading was calculated assuming that the combined "standard" keel blocks and the fantail blocks were a typical keel line in which a trapezoidal load configuration as shown in Figure 6 developed. The pumping plan was developed based on this loading. In actuality the vessel was landed on the "standard" keel blocks first and raised 2 feet. This had the effect of preloading the "standard" keel line with the higher loads near the aft knuckle before any load was imparted to the fantail blocks.

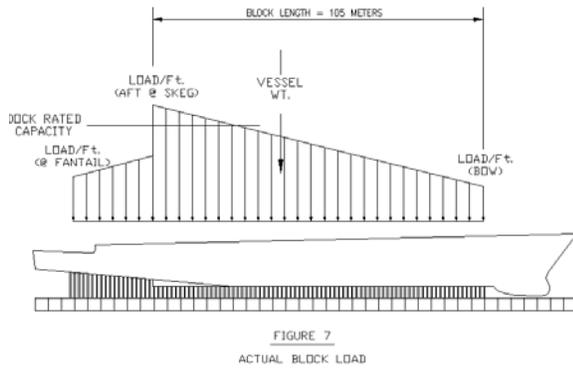
This docking procedure resulted in an actual block loading that looked approximately like that shown in Figure 7.

The load on the fantail blocks was much less than the pumping plan assumed and the load on the skeg area of the “standard blocks was much greater than the pumping plan assumed. This high load on the skeg area exceeded the design limit for the dock. This resulted in a situation very similar to the accident in example 1. The excess buoyancy under the fantail blocks was transmitted through shear in the wing walls to the overloaded skeg area. This increased the transverse bending moment causing the deck plate to buckle in that area. Other areas failed “domino style” once one area gave way.

The accident described in Case 2 was more difficult to foresee. The load per meter (load per foot) was calculated based on certain assumptions. A detailed pumping plan was developed and followed. Unfortunately, some deviations from the assumptions used for calculations had a greater effect on actual loading than anticipated. Also, seemingly minor details in the docking procedures had a significant effect on the results. If the fantail blocks had been wedged tight at the time the shims were installed they would have taken a greater percentage of the vessel's weight and relieved the overloaded skag area – probably preventing the collapse.

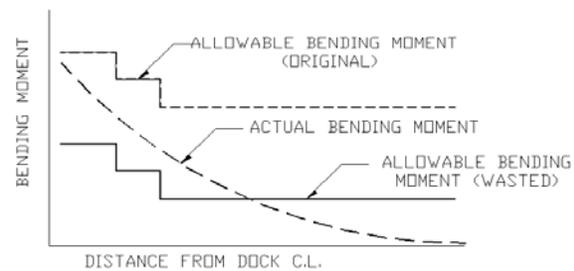
An investigation into the incident revealed the pontoon deck had significant loss of metal thickness due to corrosion. Ultrasonic thickness measurements of the plate showed the original metal thickness had been reduced by 18 to 43 percent.

Using the methods employed by Reference 1 it can be shown that a 40% loss of metal thickness in the pontoon deck results a reduction of allowable buckling stress of approximately 70% for the plate panels of the pontoon deck. This reduction in allowable stress coupled with the reduced area of the pontoon deck results in a reduction in allowable transverse bending moment of about 75%.

Figure 8 shows the allowable transverse bending moment for transverse frames of the pontoon for the original design condition and for the dock with 40% wasted of the pontoon deck as described in Reference 2. Superimposed on the chart is the actual bending moment induced by drydocking the vessel. It can be seen from Figure 8 that the dry dock had sufficient strength to dry dock the vessel in the original condition but was significantly lacking in strength once the pontoon deck had corroded.

The accident described in Case 3 could have been avoided if the condition of the dock was routinely monitored and the effects of the deterioration on critical buckling stress was realized. This would require developing corrosion criteria for all structural elements of the dock that delineates the amount of corrosion that is acceptable before allowable stresses are exceeded under normal design conditions.
